Manhole Inspection Summary

Manhole # S39W1_027MH

Location Address: **3535 3rd-Horton**

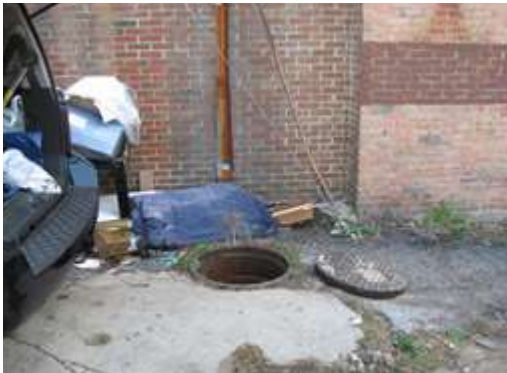
Location View

Alley between Horton & 3rd St

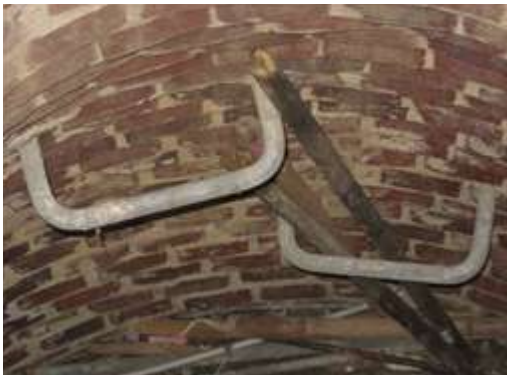
Steps Count: **2** Missing: **0** ☐ Corroded

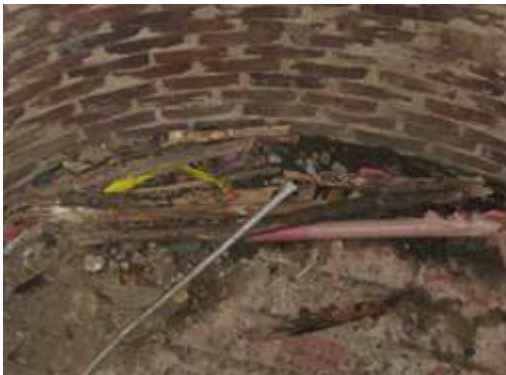
Defect 4

Comments **Manhole had large sticks and debris.**

Debris

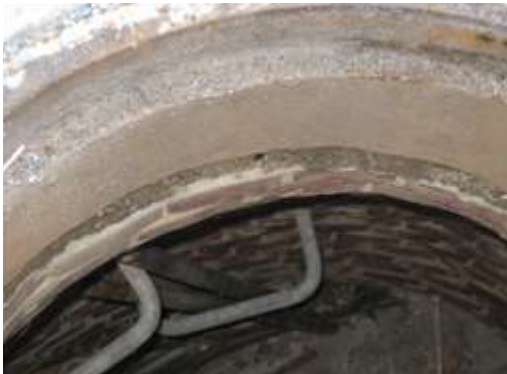
Defect 5

Frame Offset: **0.5** (in.) Condition: ☒ Sound ☐ Cracked ☐ Leaks

Frame offset

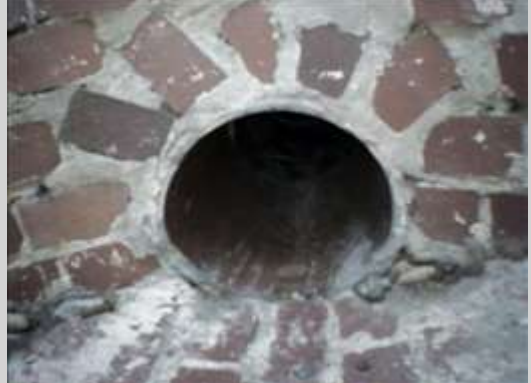
12 O'Clock Outflow

8 in. Circular Gravity Sewer
Pipe Out @ 12 O'Clock

Infiltration: **None** Pipe Seal Cond: **Sound**
